## **VSR Report**

**Voith Hydro, Sao Paulo, Brazil**

**September 2012**

Voith Hydro in Brazil tested the VSR Process, both upon a test work-piece of their own design, plus two production work-pieces: A mild steel heavy-plate half-ring weldment and a mild steel fabricated stator half-ring. Results upon the test work-piece showed significantly less distortion (3 times less) than has been achieved using thermal stress relief. The test work-piece results are shown in the table below:

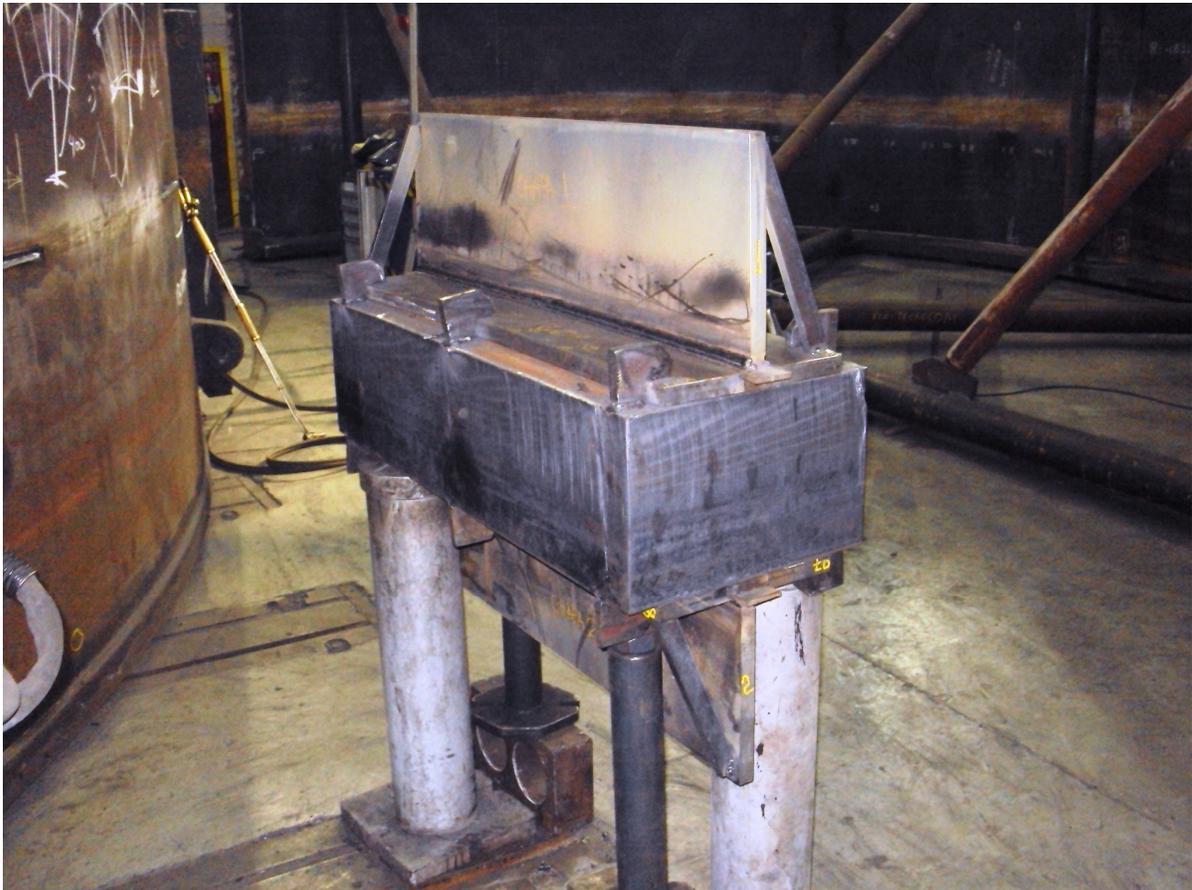
Figure 1: Test work-piece consisted of two mild steel plates welded securely together, forming an inverted "T", and clamped prior to welding to a solid block. Brackets at each end were removed prior to VSR Processing.

The test work-piece consisted of two mild steel plates, approximately 1 m L, 250 mm wide and 25 mm thick. One of the plates was clamped firmly with welded clamps to a solid block, also 1 m L and 250 mm both wide and thick. The other plate was positioned in the center of the first plate, so the two plates cross-section formed an inverted capital "T". Two passes of fillet welding on each side, ~ 6 mm wide, secured the plates together. Figure 1 shows the test work-piece, but note that the braces, one at each end, were removed prior to VSR Processing.

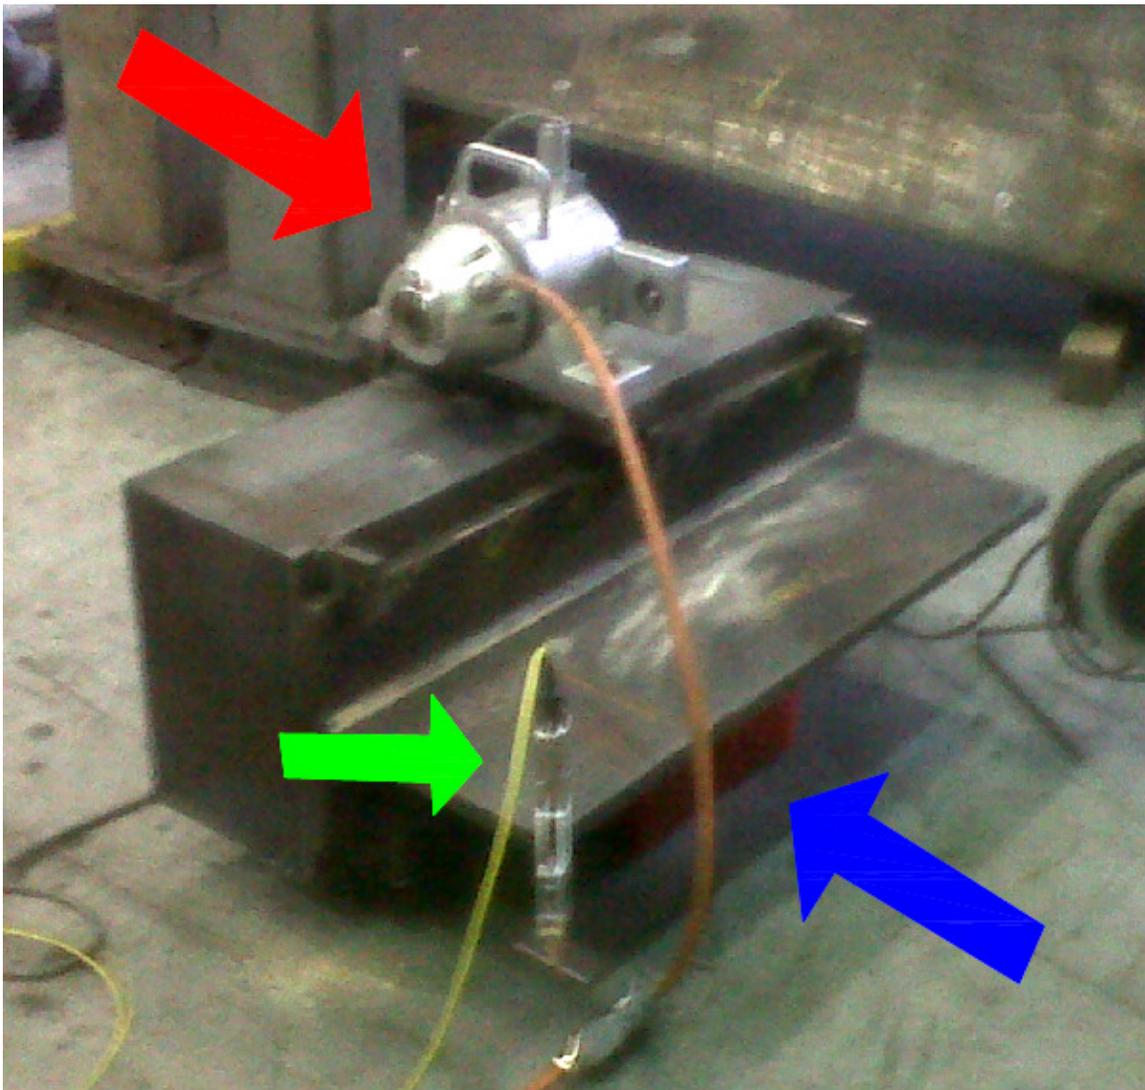
Figure 2: Test work-piece was placed on 3 urethane isolation cushions, two of which are visible (blue =>). The vibrator (red =>) was bolted to an adaptor plate that had been welded to the block. The accelerometer, a vibration sensor (green =>) was mounted on the corner of the unclamped plate, the best locale.

To mount the vibrator securely, an adaptor plate was welded to the side of the test work-piece. This plate was slightly larger than the vibrator's "footprint", and had two drilled and tapped holes, which were used to bolt the vibrator to the plate. The plate was oriented so that, using the standard side-mounting flange, the vibrator's Axis of Rotation (AOR) was in line with the length of the work-piece. The work-piece was placed on its side, atop 3 urethane isolation cushions (orange in color, with blue arrow). The vibrator (red arrow) was adjusted to 15% of the max of 4.0 in-lbs unbalance, or 0.6 in-lbs, and the accelerometer (vibration sensor, green arrow) was clamped on the corner of the unclamped plate. See Figure 2.

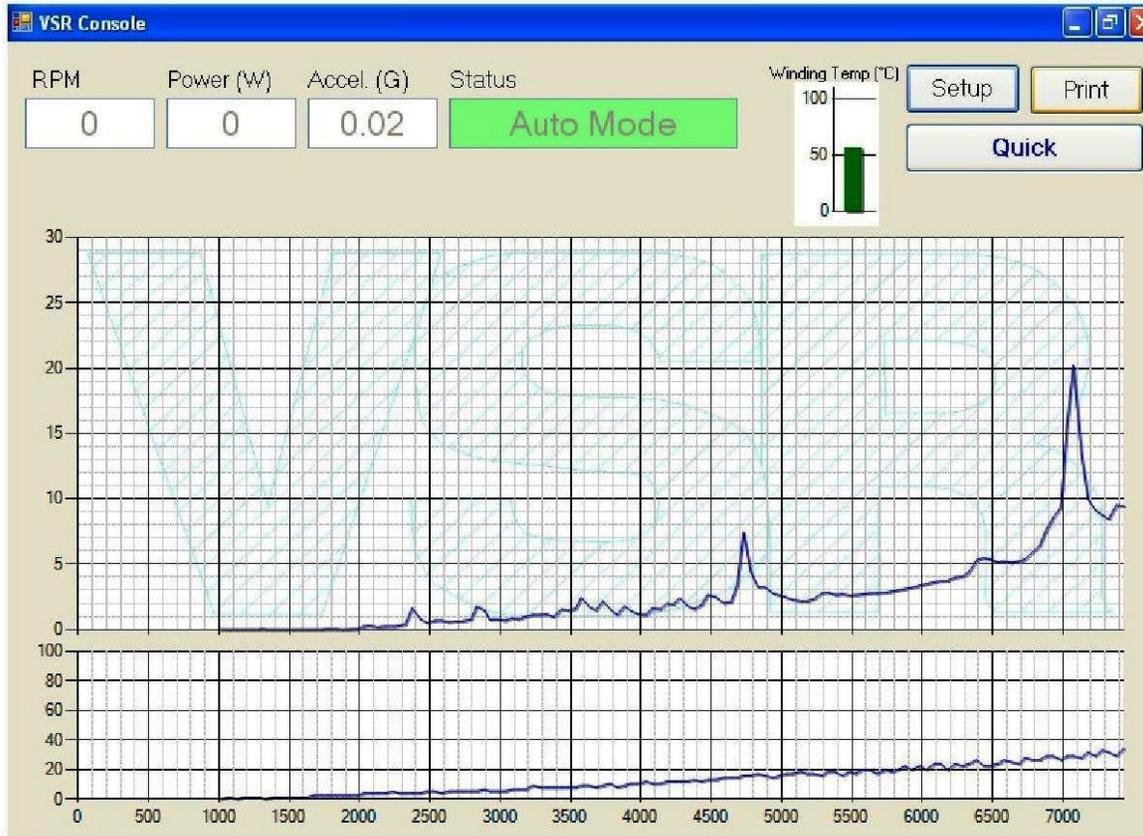
Figure 3: Quick Scan of test work-piece. VSR Charts consist of two curves: An upper ACCELERATION curve and a lower VIBRATOR POWER curve, each of these parameters plotted vertically (Y – direction), vs. a common X – axis of VIBRATOR SPEED (RPM). Both the ACC and the RPM scales are adjustable, and can be adjusted either before or after making a chart, while maintaining chart data integrity. POWER is a fixed scale, with 100 being 2.3 kW, the capacity of the BL8 vibrator.

Here the ACC Full – Scale (FS) has been adjusted to 30 g's, and the RPM FS to 7500 RPM. Resonance peaks at ~ 4500 and 7200 RPM can be seen.

Quick Scans (QS's) are plotted at a rate of 50 RPM / sec, which is too fast for high-resolution data to be recorded. QS's are plotted in blue.

Both Pre-Treatment (baseline, plotted in green) and Post-Treatment (documentation, plotted in red) Scans were made at the standard rate of 10 RPM. This rate can be adjusted prior to a scan, if needed.

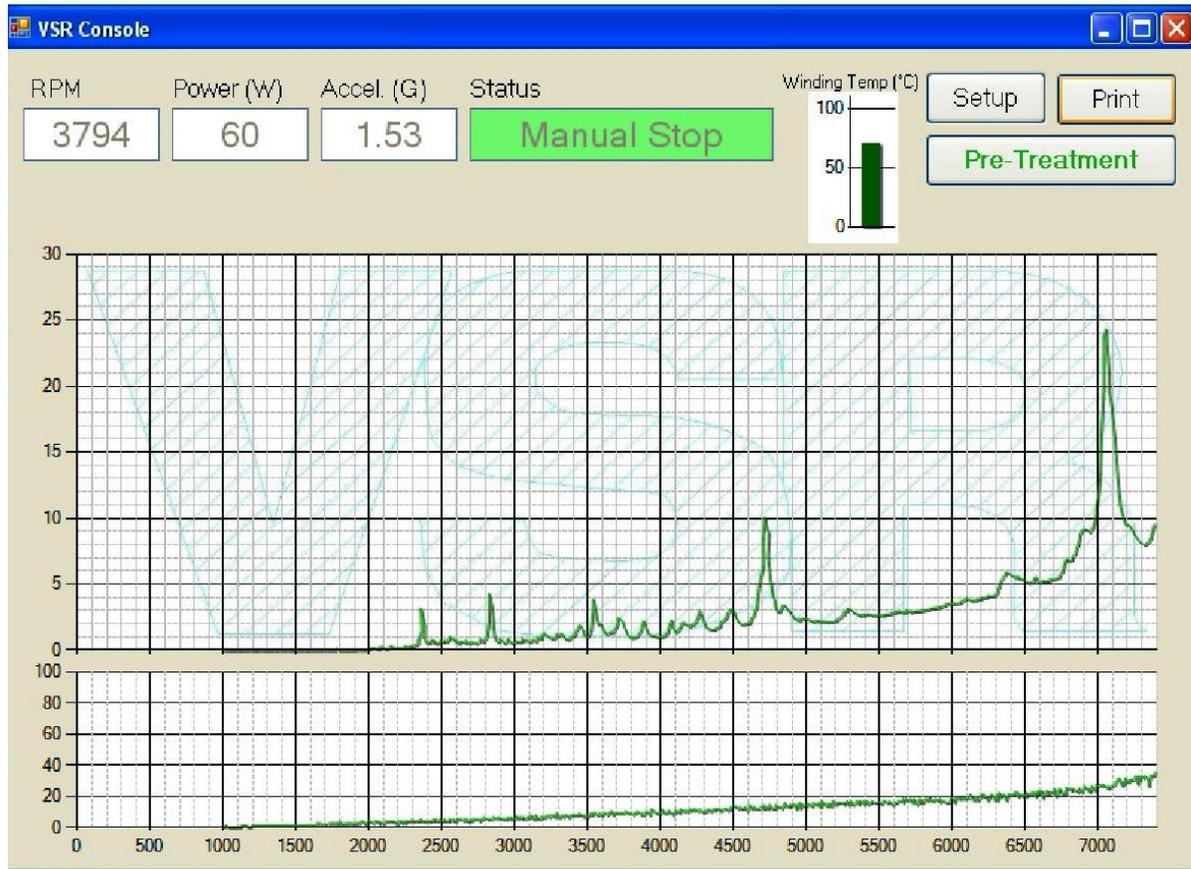
Figure 4: Pre-Scan shows a higher resolution set of data than in the QS, which is used as a baseline to perform VSR Treatment. Peaks in the ACC (upper curve) are tuned upon, and monitored for change. The classic changes during the VSR Process are peak growth or peak shifting, most often, but not always, to the left (lower frequency).

During treatment, the operator tunes the vibrator, using the Pre-Scan as a guide to tune upon peaks. A real time CURSOR, a black dot on the screen, depicts the real-time vibrator speed and work-piece acceleration. If peak growth or shifting take place, either the cursor, or the digital displays (which also display real-time data)

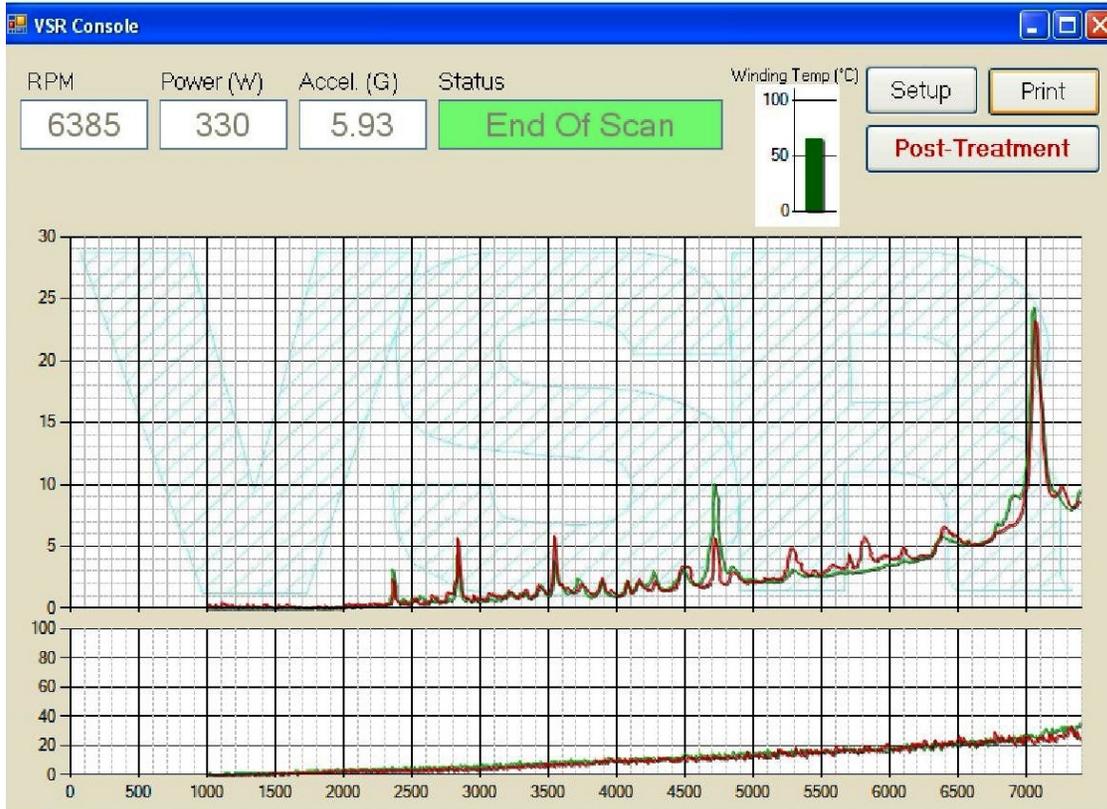
Figure 5: 1<sup>st</sup> VSR Treatment Chart shows little change. Some slight peak growth in short peaks between 5000 and 6700 RPM, together with the peak reduction at 4700 are insufficient evidence of stress relief occurring.

Little change took place during the first VSR Treatment, as shown on the completed VSR Treatment Chart, Figure 5.

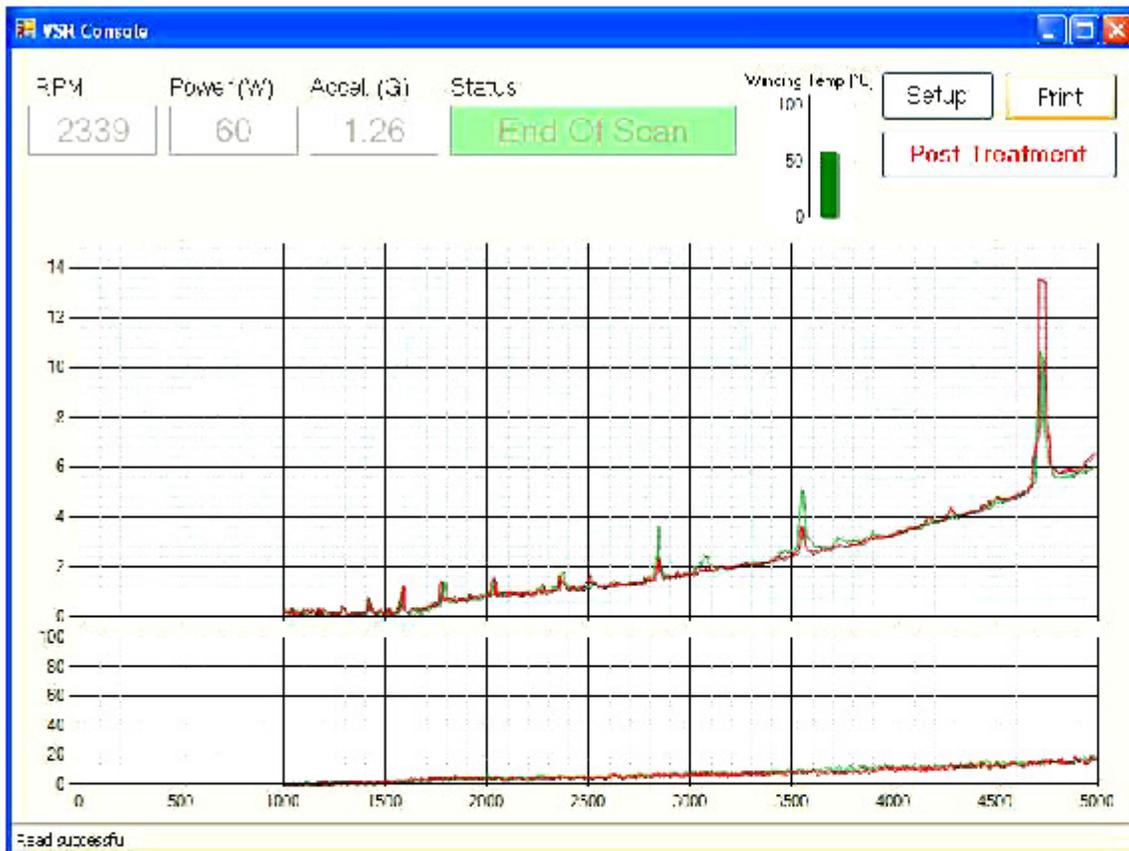
Figure 6: 2<sup>nd</sup> VSR Treatment used 70 %, or 2.8 in-lbs of vibrator unbalance, and shows significant peak growth at 4700 RPM. After peak growth max'd at almost 14 g's, the data remained stable. Treatment time was approximately 15 minutes. Scan time for each scan (Pre- and Post) was ~ 6 minutes.

Due to this modest response, a second VSR Treatment was performed at higher unbalance, but with a more limited RPM range.

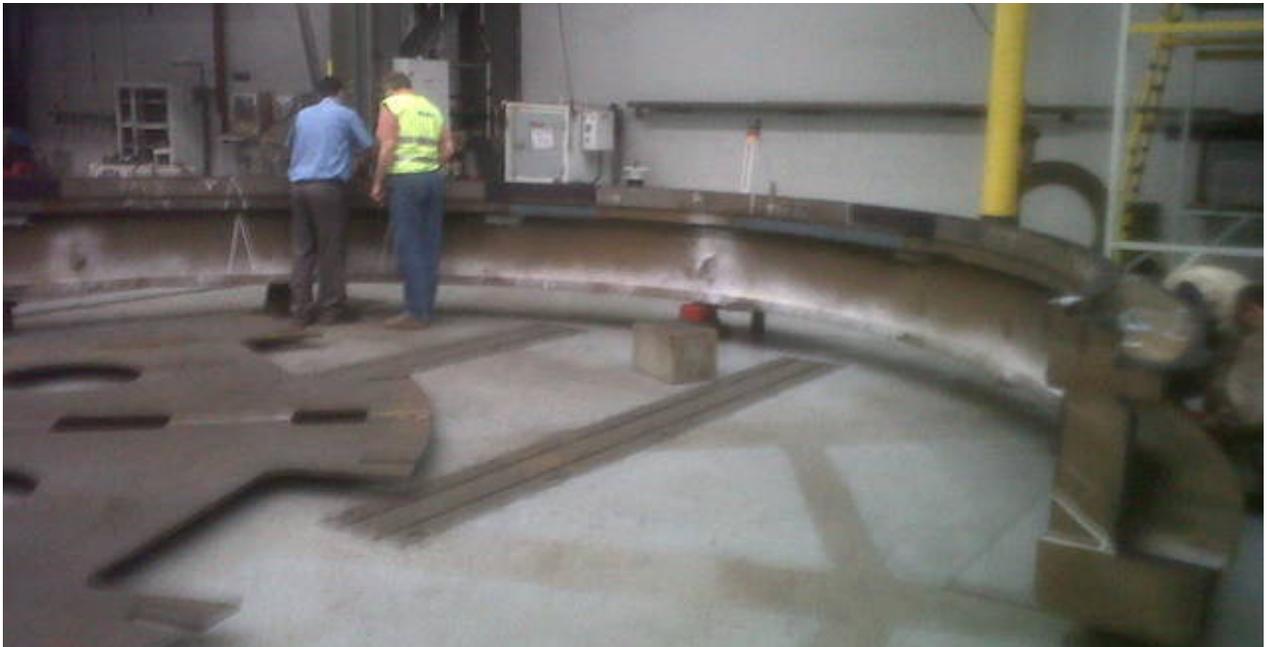
Figure 8: Welded half-ring being setup for VSR Treatment. One of three urethane isolation cushions, red in color, can be seen near the center of the half-ring. The other two were placed within 2 m of each end, the left-ward location being also where the vibrator was mounted. A similar adaptor plate was used to mount the vibrator, and vibrator's orientation was aligned approximately to the furthest portion of the half-ring, in the right foreground. The accelerometer (vibration sensor) was attached to the left end, and oriented to be most sensitive to vertical amplitude. The vibrator's unbalance was adjusted to 20% of the max, or 0.8 in-lbs. The Quick Scans and Pre-Scan (baseline) is shown in Figures 9 and 10.

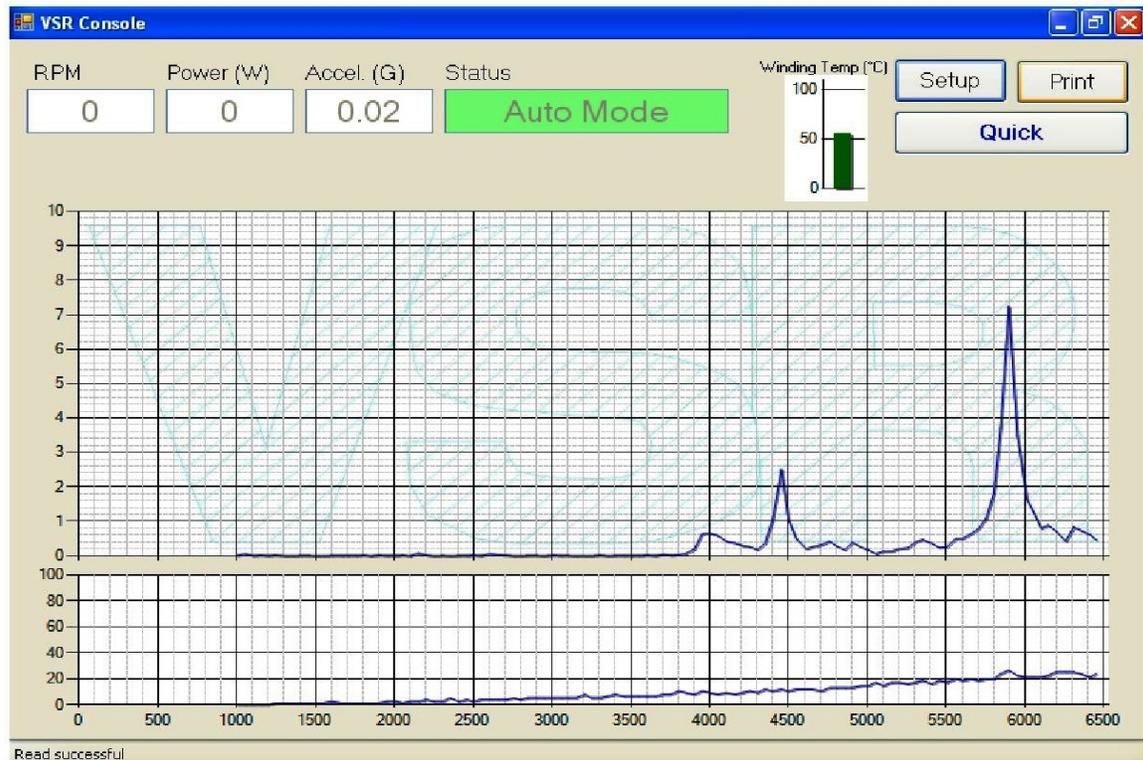
Figure 9 shows two significant peaks, which were then depicted with higher accuracy in Figure 10.

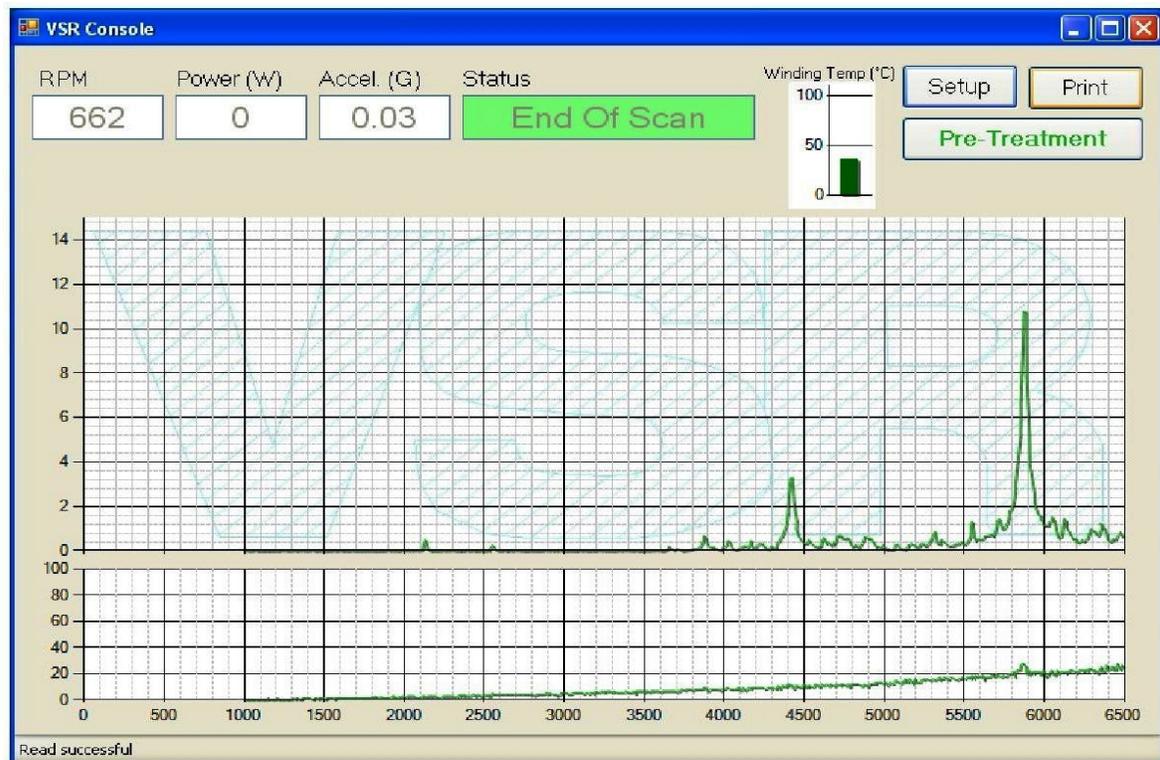
Figure 10: Pre-Scan of cast half-ring shows two significant peaks, with heights of ~ 3 and 11 g's. Although the 3 g peak changed little, the 11 g peak grew, plus a new peak, not seen before, appeared at ~ 3500 RPM. See Figure 11.

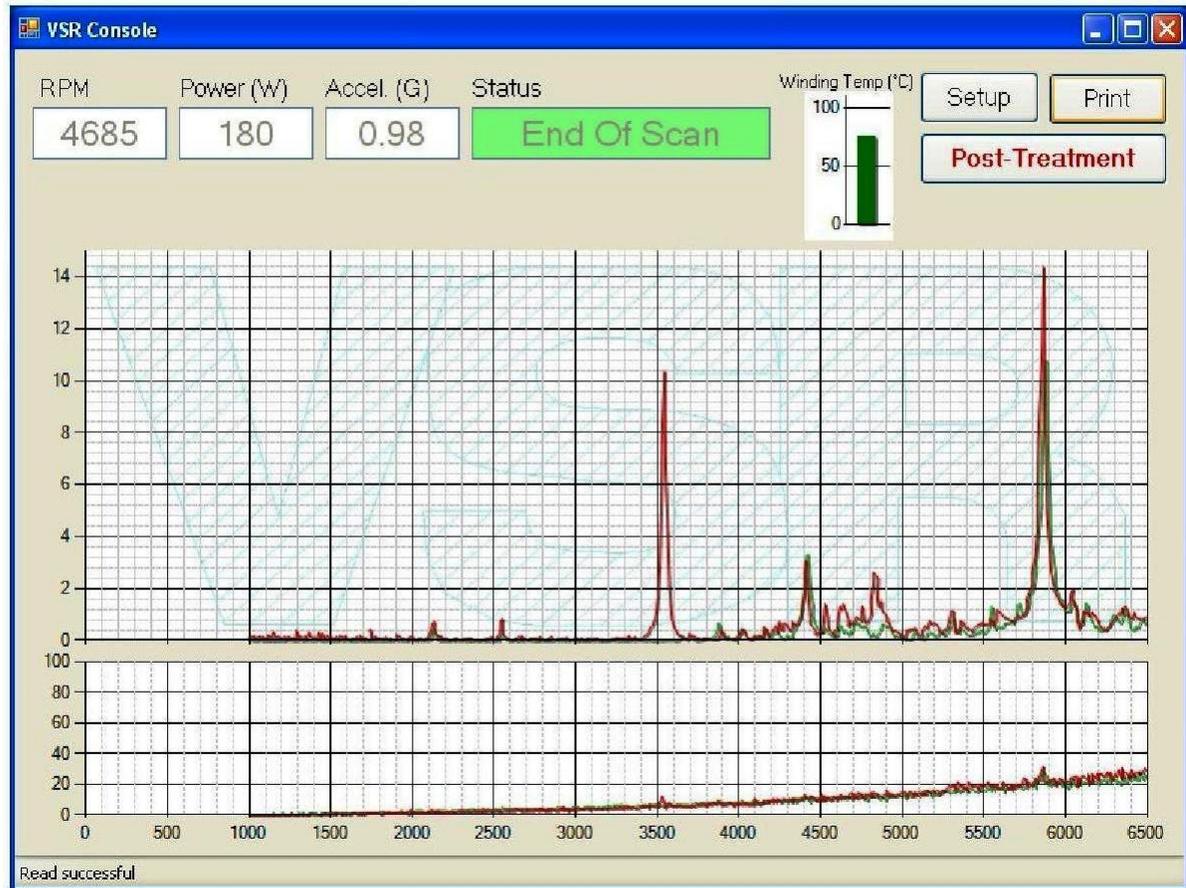
Figure 11: VSR Treatment of welded half-ring shows significant change at the largest peak, at ~ 5800 RPM, plus a new peak, not seen before, at ~ 3500 RPM. Since the 3500 RPM peak had not been seen, Post-Scan was stopped to treat this peak, but little additional change took place, so the Post-Scan was begun again and completed. Total treatment time, with setup, scans, treatment, and knock down, was ~ 2 hours.

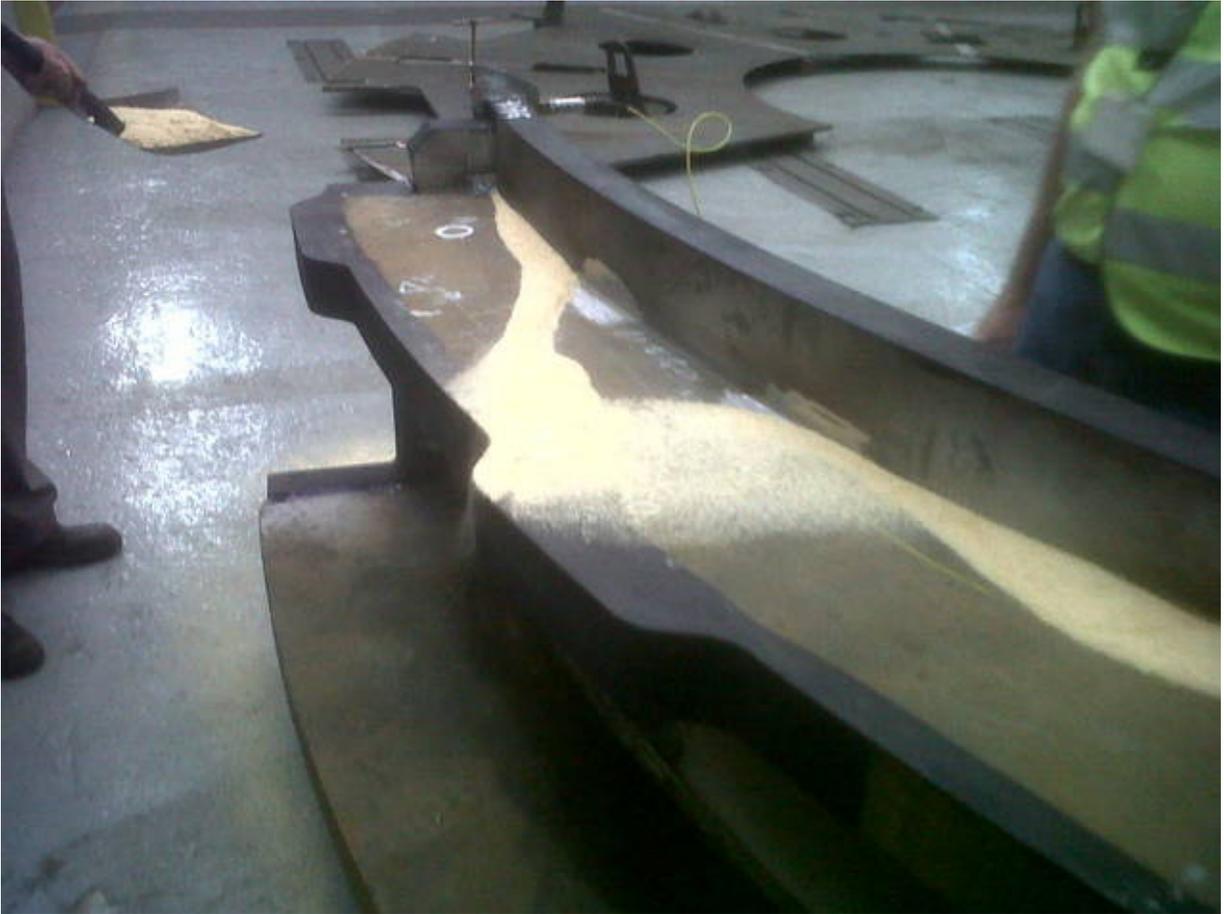
Figure 12: A portion of the nodal pattern on the half-ring. Five such nodes occurred over the full length of the structure, on the largest peak, but fewer on other, lower frequency peaks. A node is a good location to place the vibrator, and also cushions, but not the accelerometer. Using nodal patterns to improve VSR setups is a standard portion of the VSR Operator Training.

To further illustrate the physics of the VSR Process, which employees resonant vibration to amplify the force from the vibrator, which then is sufficient to stress relieve, sawdust was placed on the half-ring. Besides resulting in a peak in amplitude, resonating of a large solid body also generates a clear, stationary pattern on the body of high and low amplitude.

Powder, such as sand, Oil Dry ®, or sawdust, spread on horizontal surfaces of such a resonating body, will be driven off the high amplitude locations, and come to rest on low amplitude locations, which are called **nodes**. Different nodal patterns occur with different resonant peaks, so the way the vibrator's effect is distributed is not by moving the vibrator, but by tuning it to different peaks.

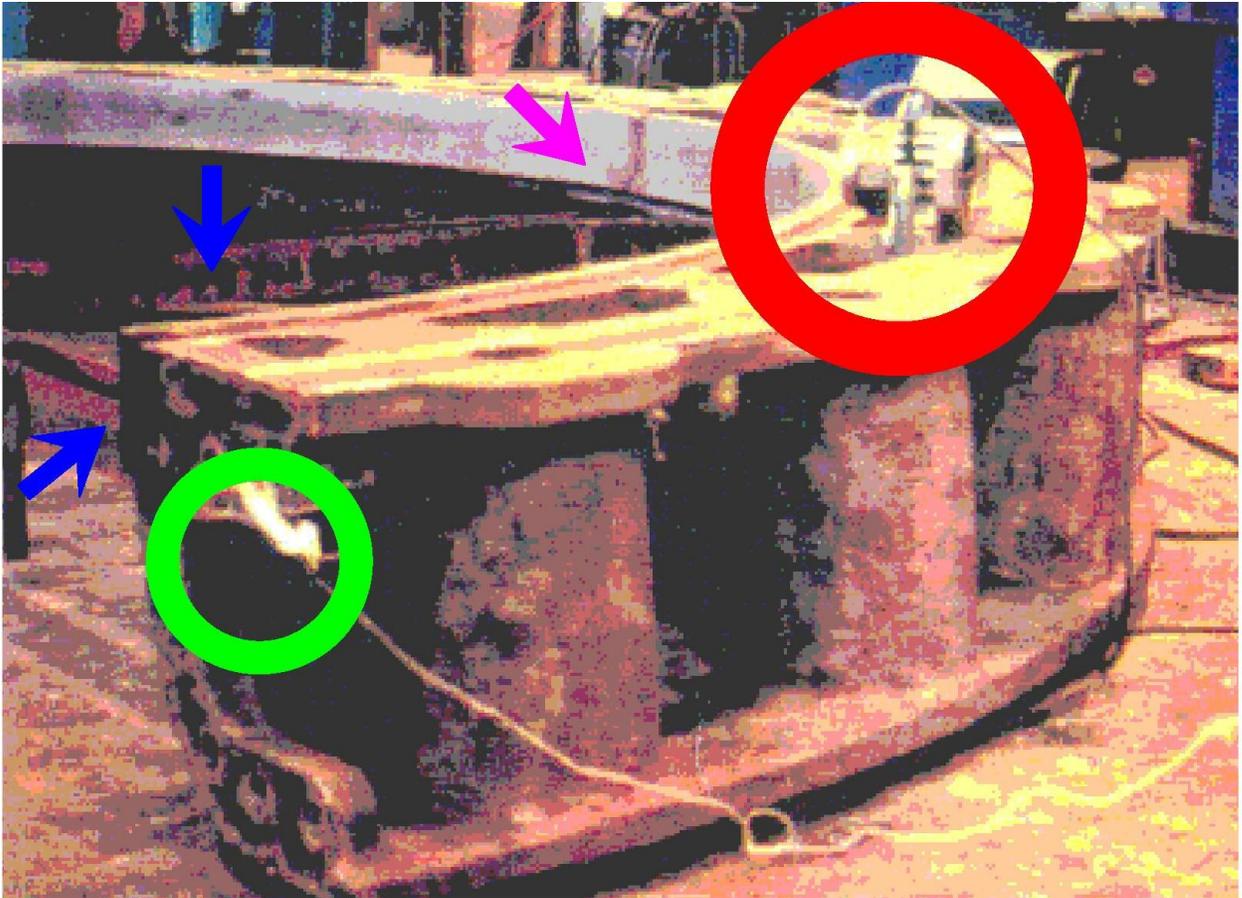
Figure 13: Voith Hydro York, PA VSR 1997 Setup: Bottom ring underwent extensive weld repair, including a stainless steel liner insert, 250 mm wide and 30 mm thick, in two sections per half.

The Vibrator is marked with a red circle.

The Accelerometer is marked with a green circle

The braces are marked by blue arrows.

The butt-weld seam is marked with a magenta arrow.

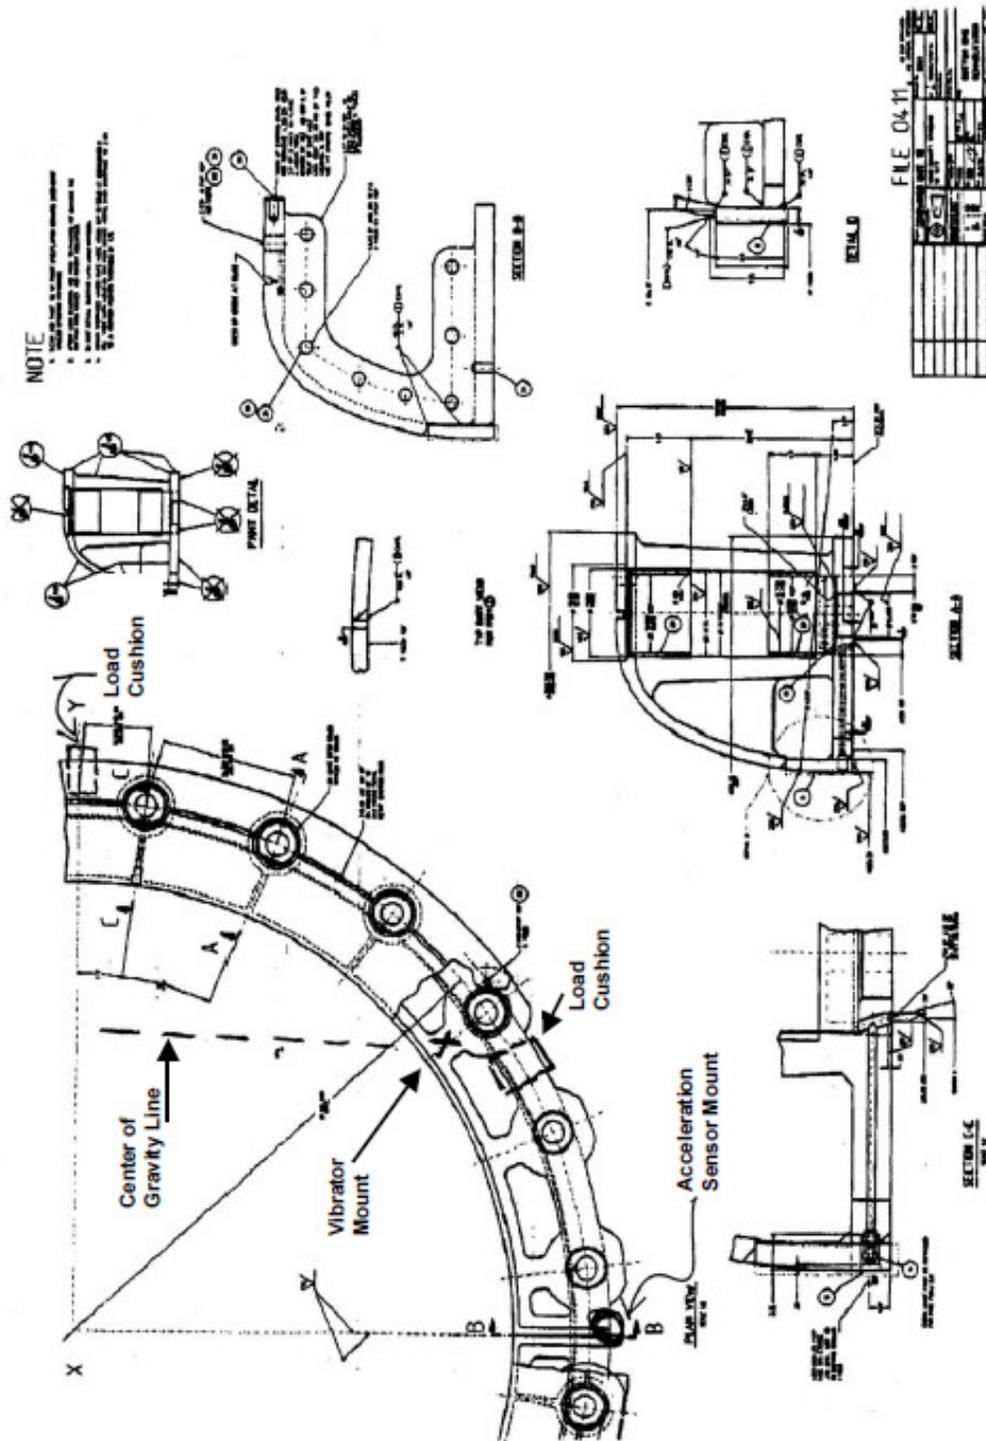
Figure 14: Drawing of bottom ring that underwent weld repair in 1997, which included astainless steel plates welded to its inside diameter.

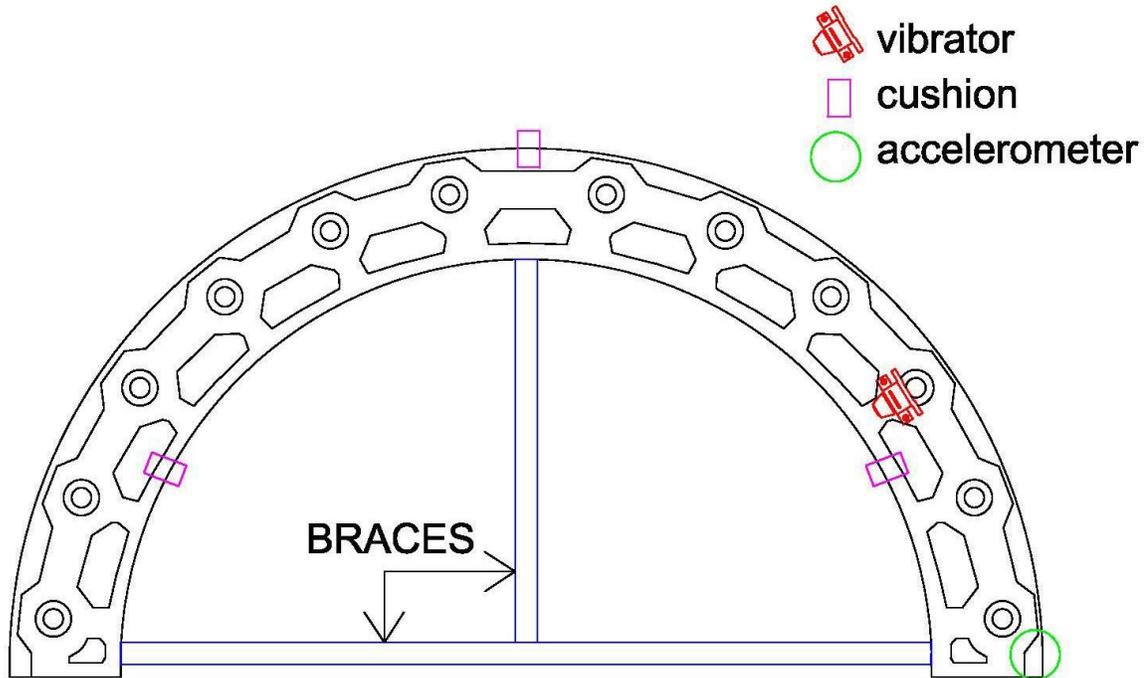
Figure 15: VSR Setup / Plan View used to stress relieve bottom ring halves shown in Fig 14. Without use of the VSR Process, brace removal would result in tightening of the span across the long brace. Once the end of the long brace was cut, the half-ring would grab it, due to distortion. Removing the braces required either using a sledge hammer and / or jack, or cutting out the brace in sections. Once the braces were fully removed, the typical distortion across the span was – 6 to – 12 mm.

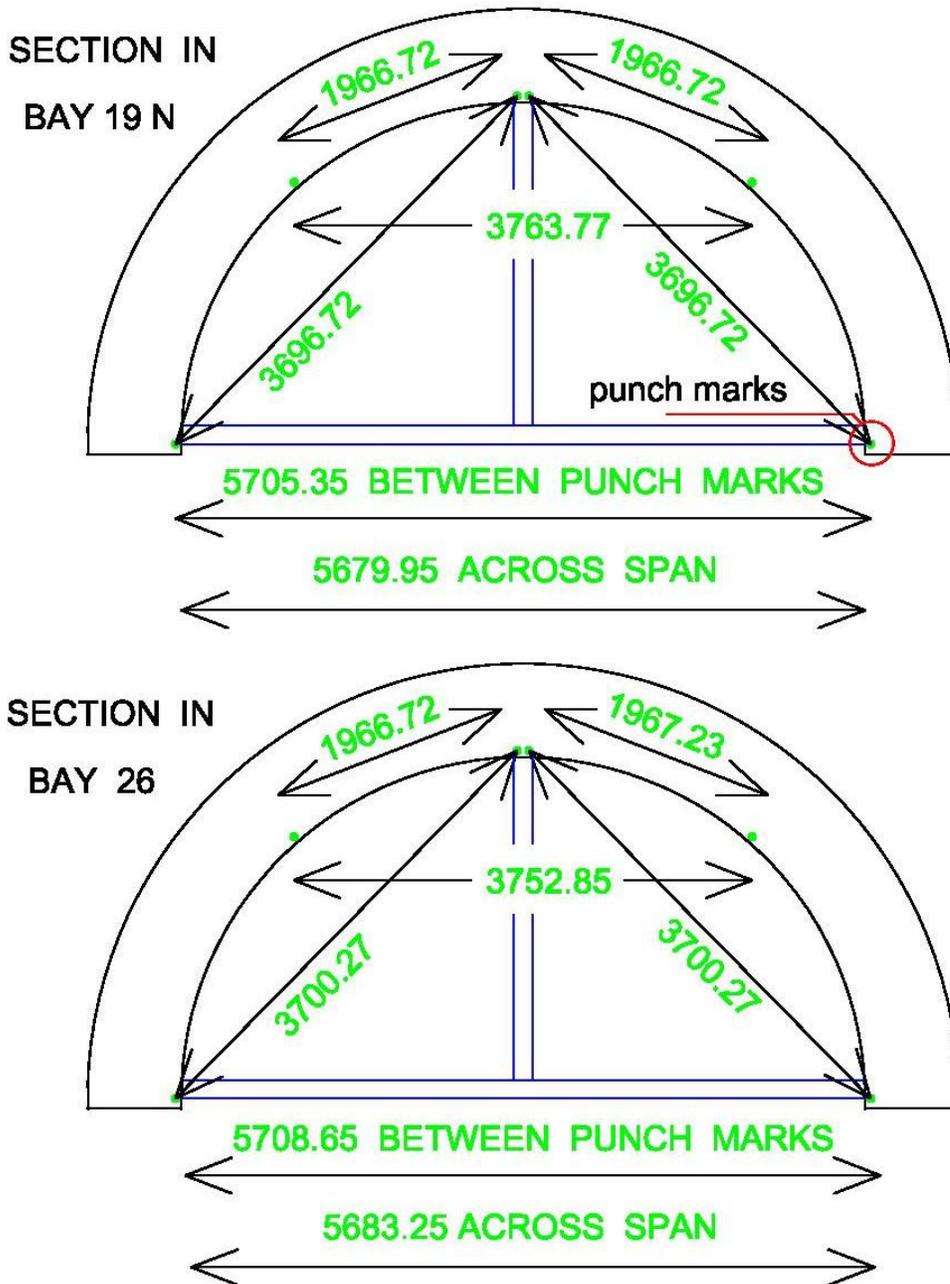
**DIMENSIONAL MAP OF RING HALVES BEFORE BRACE REMOVAL  
DISTANCE BETWEEN PUNCH MARKS SHOWN IN MILLIMETERS**

Figure 16: Before brace removal, six punch marks were made on each ring half, to track the change in shape that would take place, comparing before and after brace removal. Numbers in green are before brace removal. Note: Originally these distances were measured in inches, but have been converted to millimeters.

For this work, prior to brace removal, punch-marks were made at six points near the ID of each ring-half. A precision tape was then used to measure the distances across the large and small spans between the punch marks. The dimensional map, showing the distances of both ring halves, is shown in Figure 16.

After the punch marks were made, and the first data set was gathered (green in both Figures 16 and 18, the braces were torch-cut.

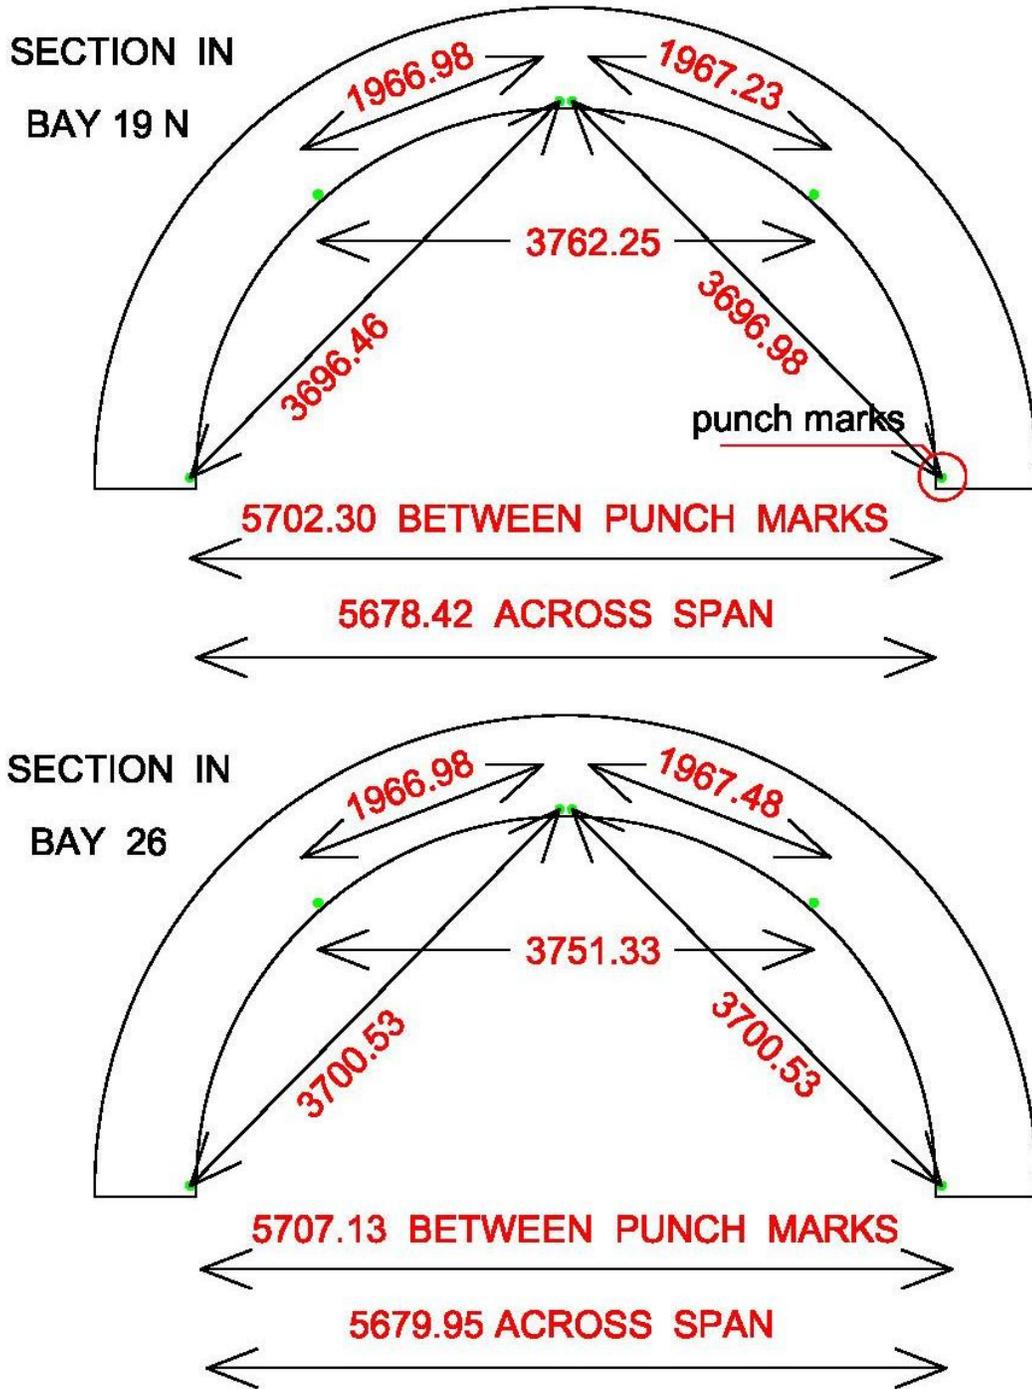
**DIMENSIONAL MAP OF RING HALVES AFTER BRACE REMOVAL  
DISTANCE BETWEEN PUNCH MARKS SHOWN IN MILLIMETERS**

Figure 17: Dimensional map of ring halve after brace removal. Changes in distances, together with distances between punch marks and arc spans are shown in Figure 18.

Figure 18 Dimensional data from Voith Hydro York 1997 bottom ring weld repair project shows a small change in dimensions after brace removal, compared with the historical change of 6 – 12 mm. This small change kept the work-piece “within its drawing”, i.e., eliminated the need for corrective straightening, besides allowing the braces to fall out after being cut.

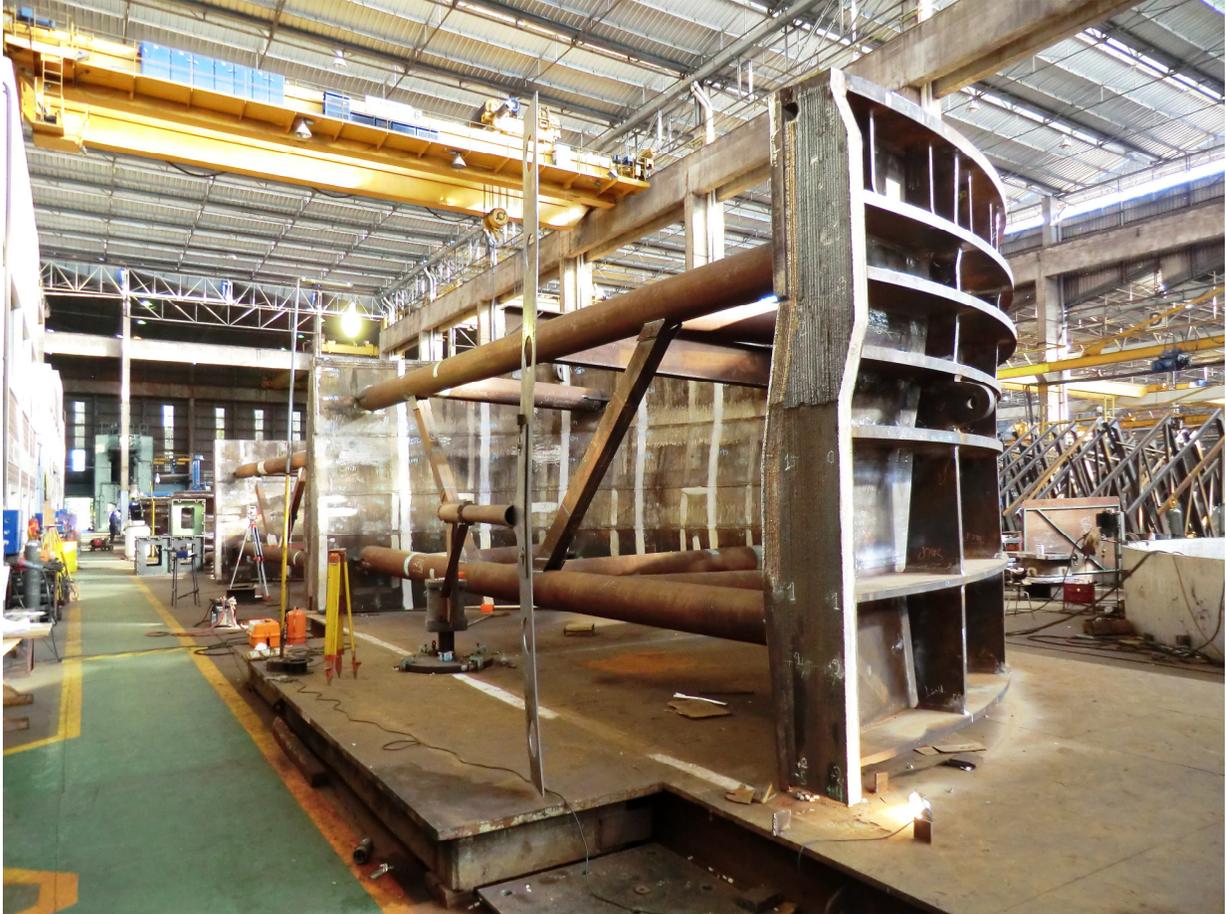
Figure 19: Discharge ring for IMPSA project, fabricated by CIE in Paraguay. Again, after fabrication, the half rings were VSR Processed, and then the braces were removed. Distortion was nominal, so that machining was able to commence, without additional / corrective manufacturing steps.

Such a technique might well reduce the distortion seen during fabrication of stator half rings. Numerous hydroturbine builders employ such a method, not only on stators, but upon discharge ring fabrication, an example of which is shown in Figure 19.

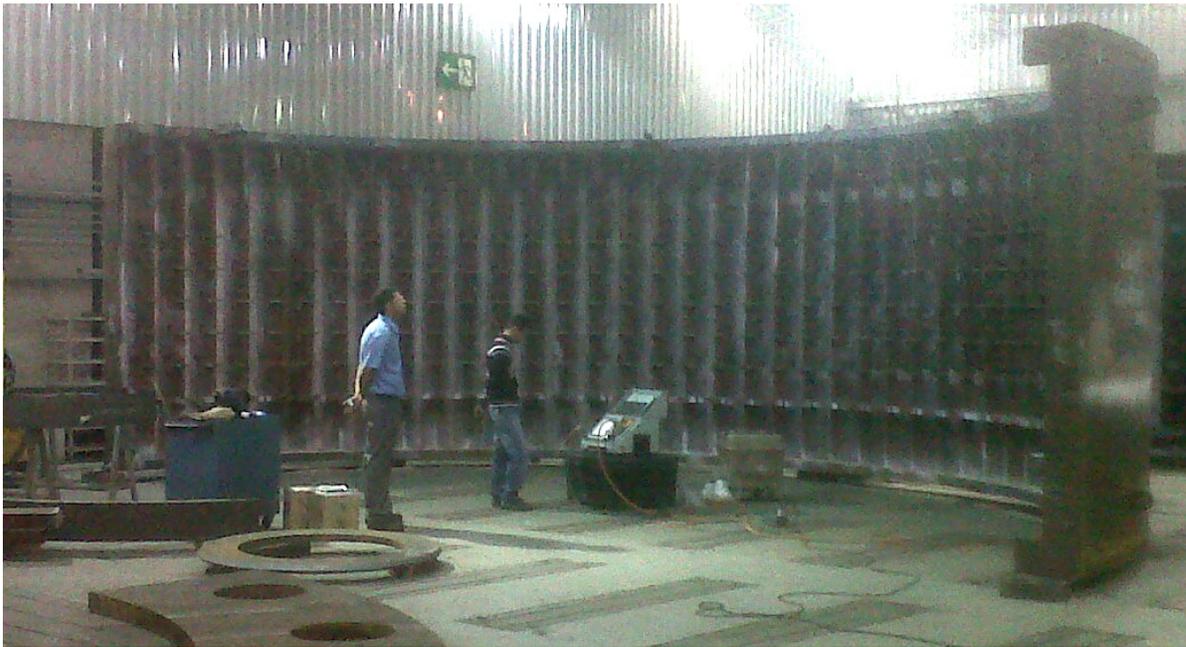
Figure 20: Stator half-ring being setup for VSR Treatment. Setup was very similar to the cast half-ring, using three cushions (although they were gathered in pairs, totaling 6, due to the work-piece weight) Two treatments were performed, using first a low unbalance, high speed range, then a higher unbalance, limited speed range. Both treatments showed change, but less during the 2<sup>nd</sup> treatment. See Figure 21.

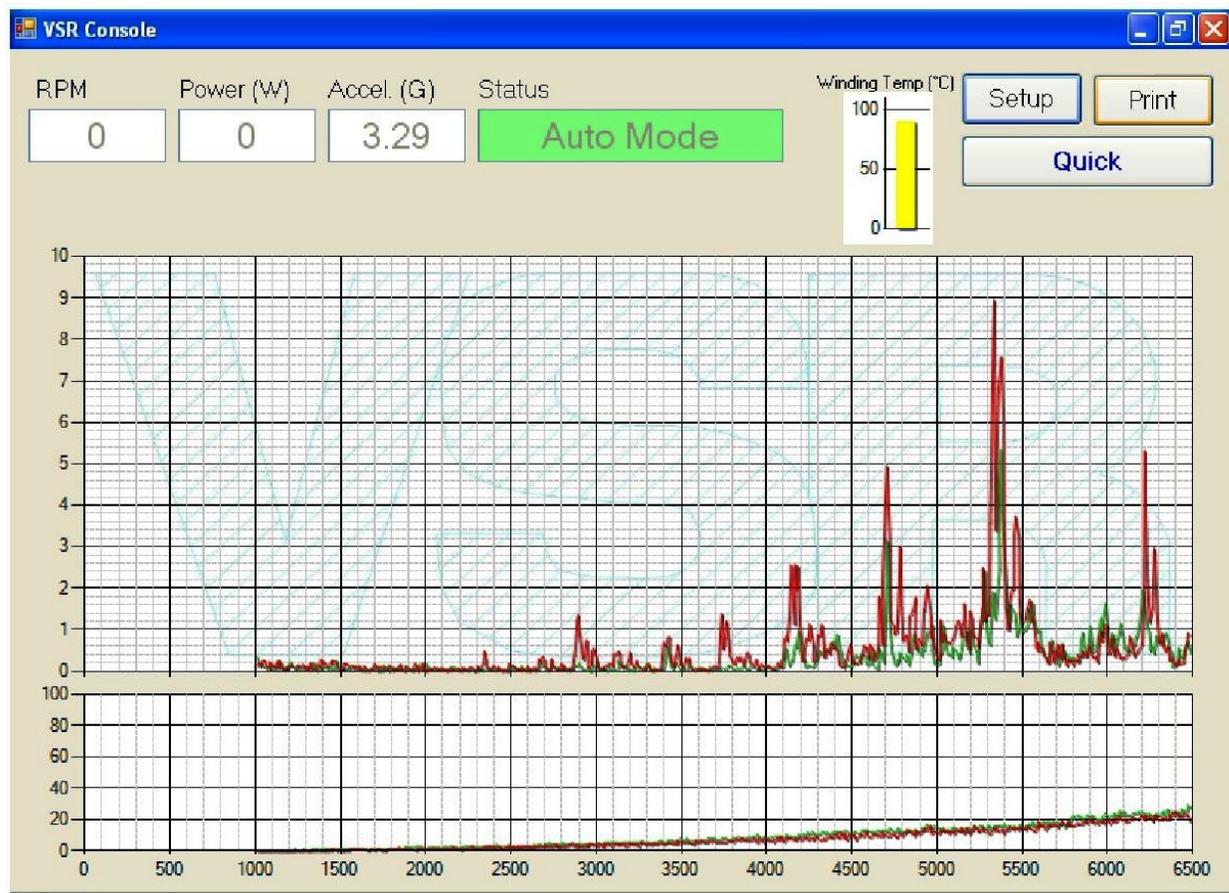
Figure 21: Treatment of stator frame using 20 % unbalance, and 6500 RPM max speed.
