## **VSR Report**

**Voith Hydro, Sao Paulo, Brazil**

**September 2012**

Voith Hydro in Brazil tested the VSR Process, both upon a test work-piece of their own design, plus two production work-pieces: A mild steel heavy-plate half-ring weldment and a mild steel fabricated stator half-ring. Results upon the test work-piece showed significantly less distortion (3 times less) than has been achieved using thermal stress relief. The test work-piece results are shown in the table below:

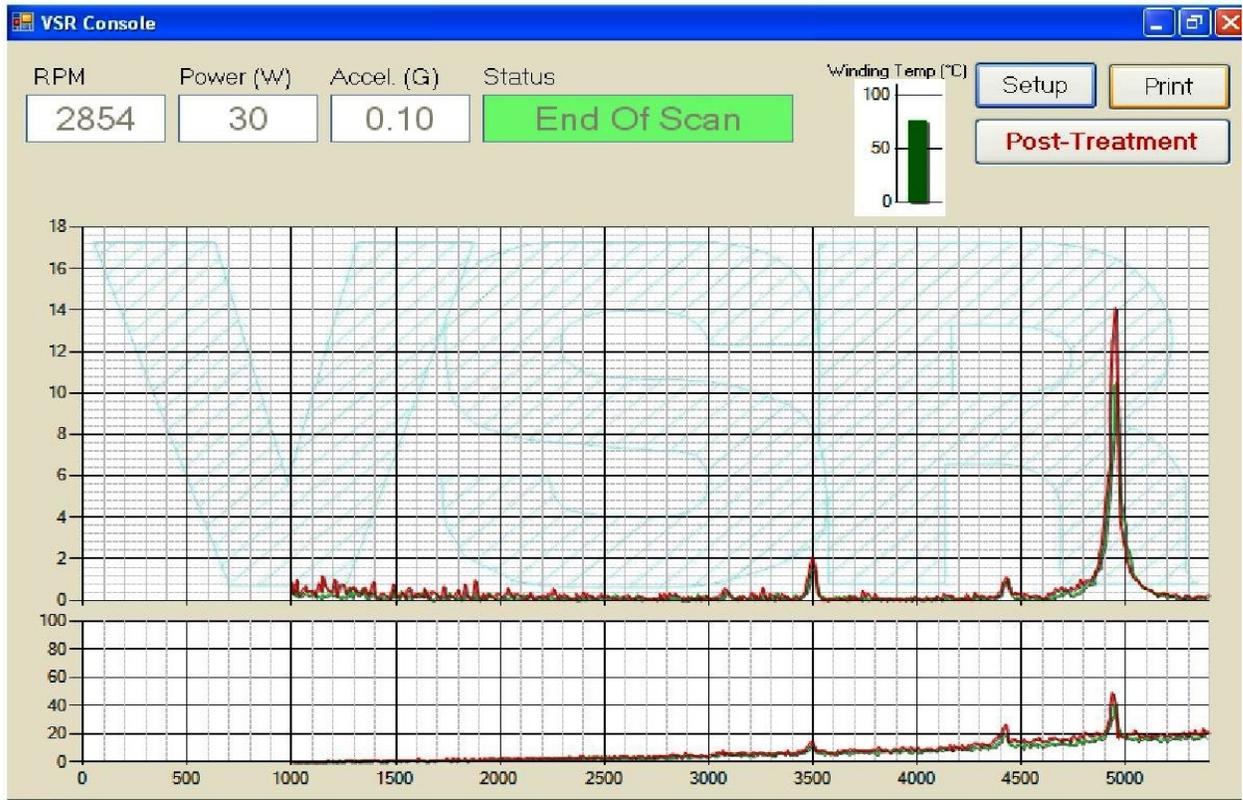
Figure 22: 2<sup>nd</sup> VSR Treatment used 40% unbalance, but a max RPM of 5500. Although less change took place, a significant growth of the peak near 5000 RPM justified the 2<sup>nd</sup> treatment.
