VSR REPORT

EBCO Industries

Stress Relief Stabilization of

Four Boeing aerospace lifting frames

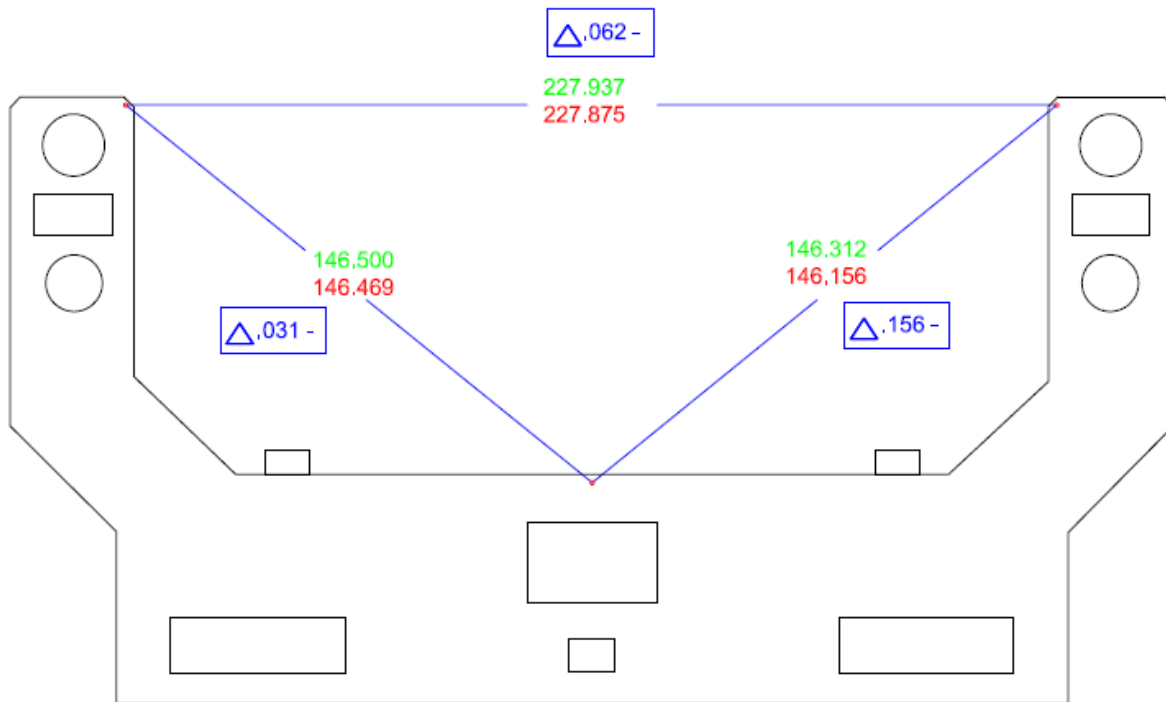
Figure 8: Dimensional measurements made before and after VSR Treatment and major brace removal of Part 1, Unit 2 show nominal change. Punch marks were made 2” inches inwards from the inside corners of the workpiece “arms”, and at a midpoint on the structure’s main body. Green data is as welded, with braces intact; red is after VSR Treatment and brace removal. Blue boxes show net differences, the minus signs after the numbers indicating the change (delta) was negative, i.e., net reduction in dimension.

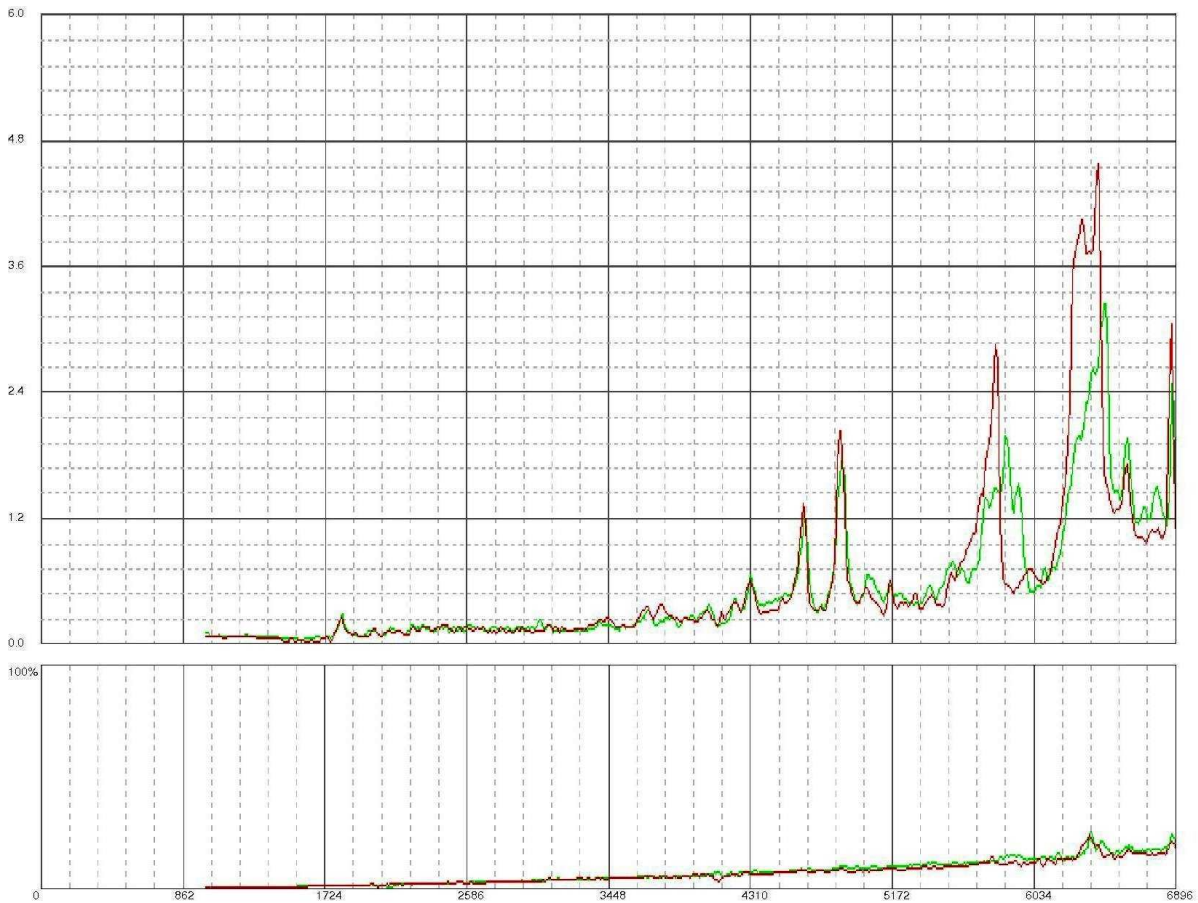
Figure 9: 1st VSR Treatment of Part 2, Unit 1. Approximately doubling of the height of the peaks in the 5 – 7 KRPM range are classic changes in resonance pattern seen during the VSR Process.

RPM FS = 6900 RPM
ACC FS = 6 g's
UNBALANCE = 0.4 in-lbs.
POWER FS = 2.2 kW (fixed)
SCAN RATE = 10 RPM / SEC

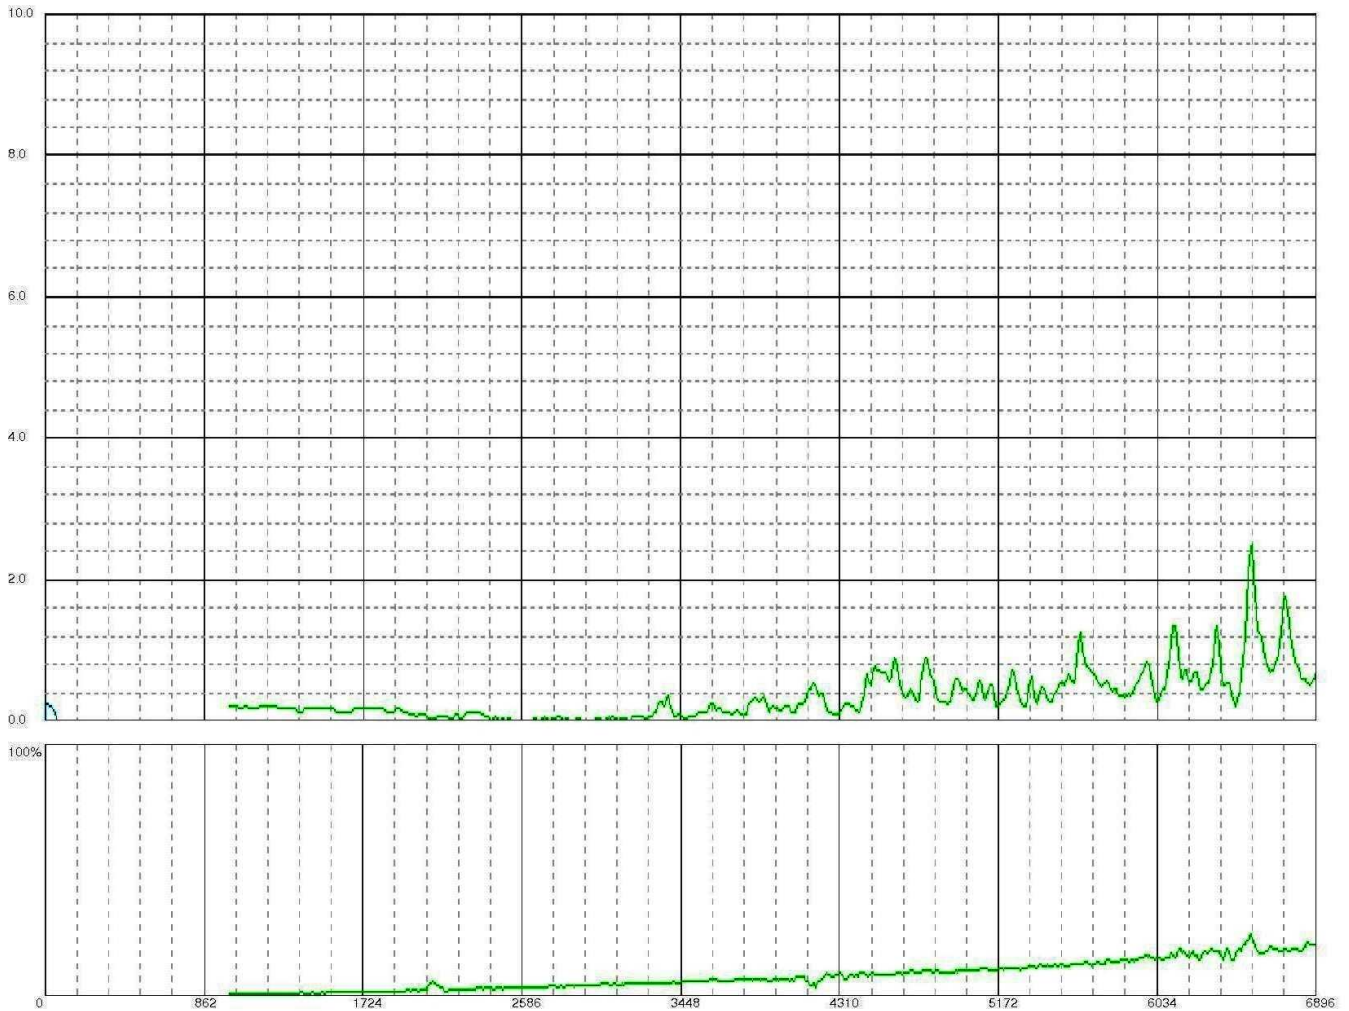
Figure 10: 1st Pre-Scan of Unit 3. This chart was recorded with too large an FS, forcing to the data to be in the low portion of the acc scale. However, distinct peaks can be seen in the region above ~ 5.3 KRPM. An ACC FS of 4 – 6 g’s would have made the data more visible.

- RPM FS = 6900 RPM**
- ACC FS = 10 g’s**
- UNBALANCE = 0.4 in-lbs.**
- POWER FS = 2.2 kW (fixed)**
- SCAN RATE = 10 RPM / SEC**
