VSR REPORT

ALLOY ENGINEERING Berea, OH November 2015

Alloy Engineering (AE) is a full-scale fab and machine shop, specializing in fabrication of exotic and high-temperature alloys. In this project, a series of ten polished austenitic stainless plates were rolled and seam welded, forming tubes that were ~ 78" long, 28" OD, and having 1/2" wall thickness.

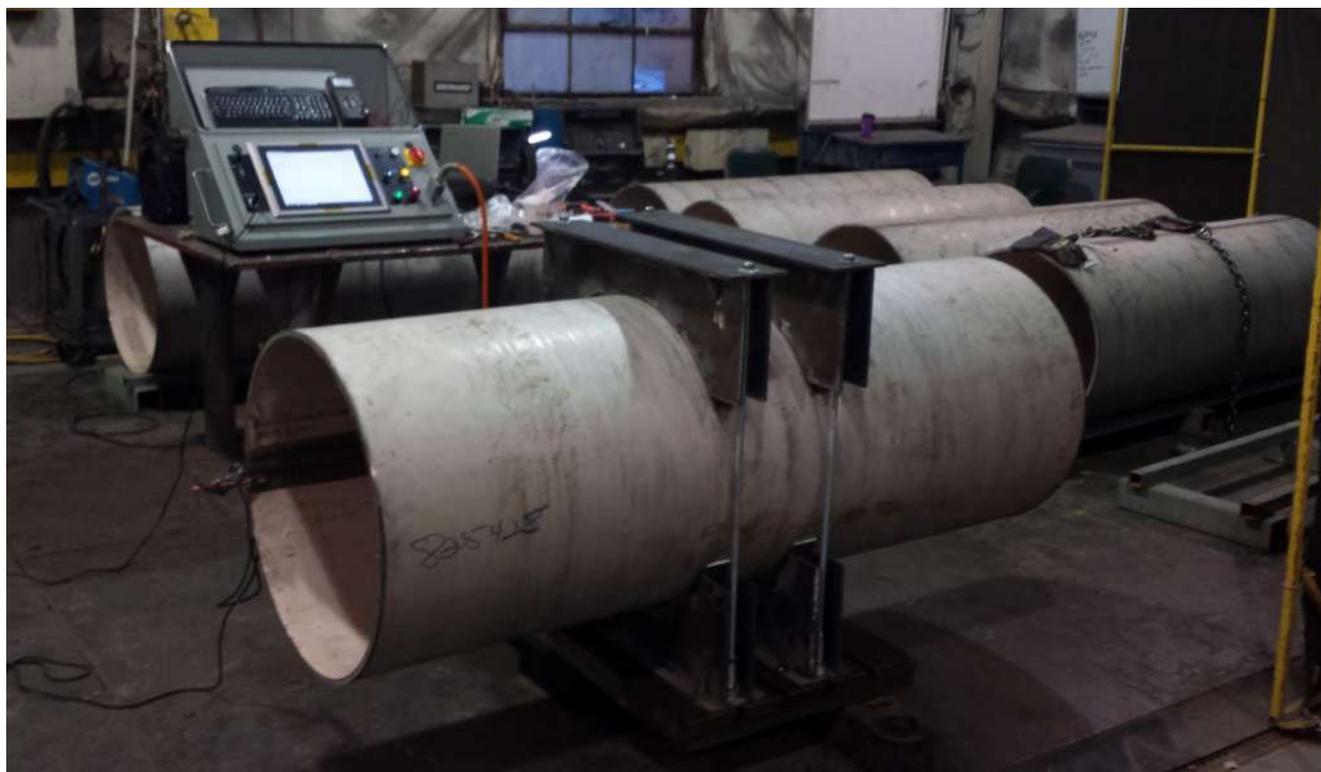
Figure 1: VSR Setup used to stress relieve tubes, one of which is mounted upon a fixtured setup shown in the foreground. A T-slotted fixture plate, ~ 45" X 26" X 5" and weighing ~ 850 lbs., has mounted upon it two "saddles", whose contact surface with the tube is a rolled steel plate, very slightly larger than the tube OD. A similar saddle is clamped down from above. The saddles were separated by only 10" so that the majority of the workpiece was free to respond to vibration in an unrestricted manner, thus revealing their resonance pattern and undergoing sufficient flexure, a key requirement of the VSR Process, to cause effective stress relief.

The accelerometer (a sensor whose output is proportional to acceleration) was placed on the end of the work-piece, adjacent to the weld-seam, and was oriented so as to be most sensitive to horizontal amplitude. The accelerometer clamp (if not the accelerometer) is visible in Figure 1, in the left mid-foreground. The parameter acceleration is used, as opposed to velocity or displacement, since it is the best parameter to monitor the dynamic load (force) induced in the work-piece, consistent with Newton's 2nd Law: $F = ma$ (Force is equal to mass X acceleration). Independent research has shown that load or pressure within the workpiece is the correct parameter to gauge the intensity of external excitation.

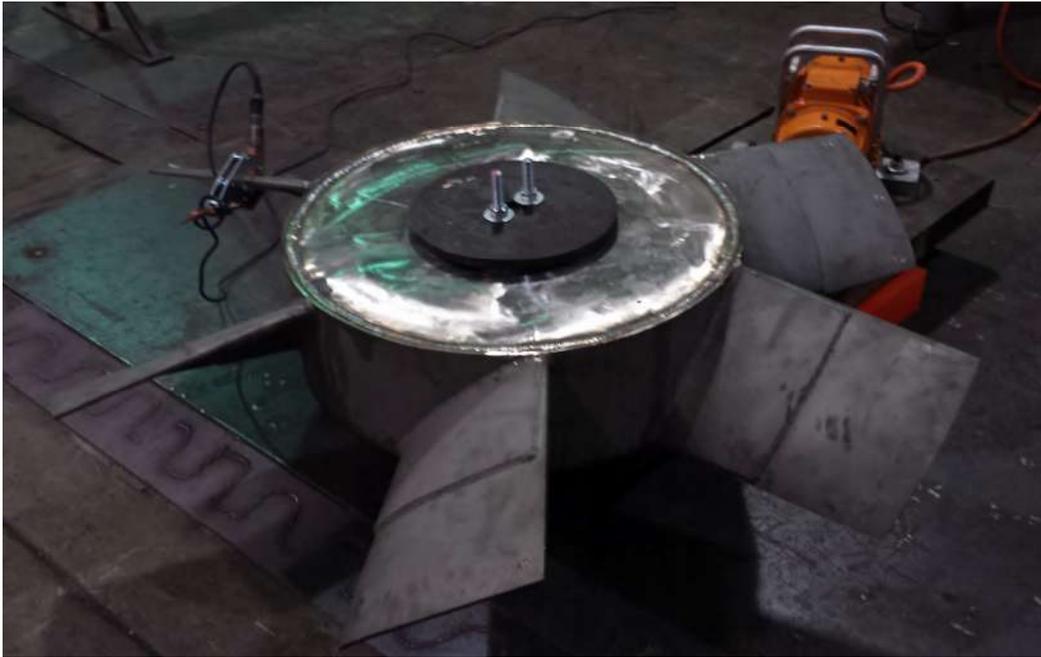
Figure 16: VSR Setup used for stress relief of Alloy 800 fan. Rotary devices that are “live” often will undergo sufficient change-in-shape in early operation to cause change in dynamic balance. This can cause a previously dynamically balanced component to go out-of-balance, almost certainly shortening, at times catastrophically, component life. The purpose of performing a stress relief upon such a part is to prevent such changes-in-shape that cause out-of-balance events to occur.

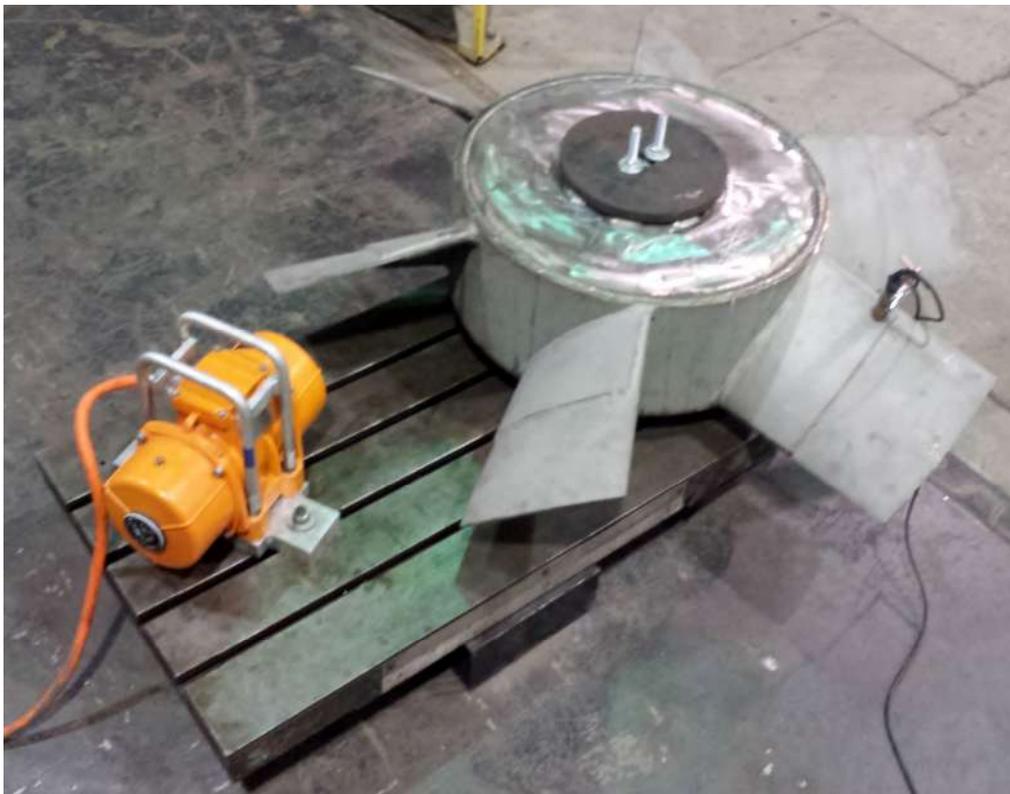
Figure 16: Another view of the fan VSR Setup shows more detail of the T-slotted base plate.
